***MELODY LAKE
DAM REPAIRS
ASSOCIATION
VOLUNTEERS MAKE THE
DIFFERENCE***

**MELODY LAKE IS A 40+ ACRE
LAKE IN THE TOWN OF WILLET.
THE DAM WAS BUILT IN THE MID
1800'S TO PROVIDE A RELIABLE
WATER SOURCE TO THE
DOWNSTREAM MILLS IN THE
HAMLET OF GEORGETOWN.**

THE DAM IS A CLASS C, HIGH HAZARD DAM CONSTRUCTED OF DRY, LAID UP NATIVE STONE, SIMILAR TO A FARMERS STONE WALL. THE DAM IS APPROX. 27'H X 10'W (TOP) X 26'W (BASE) AND 120'L. THE DAM IS A GRAVITY TYPE DAM WITH NO KEY AND RELIES ON IT'S MASSIVE WEIGHT TO PROVIDE STABILITY AND PREVENT SLIDING.

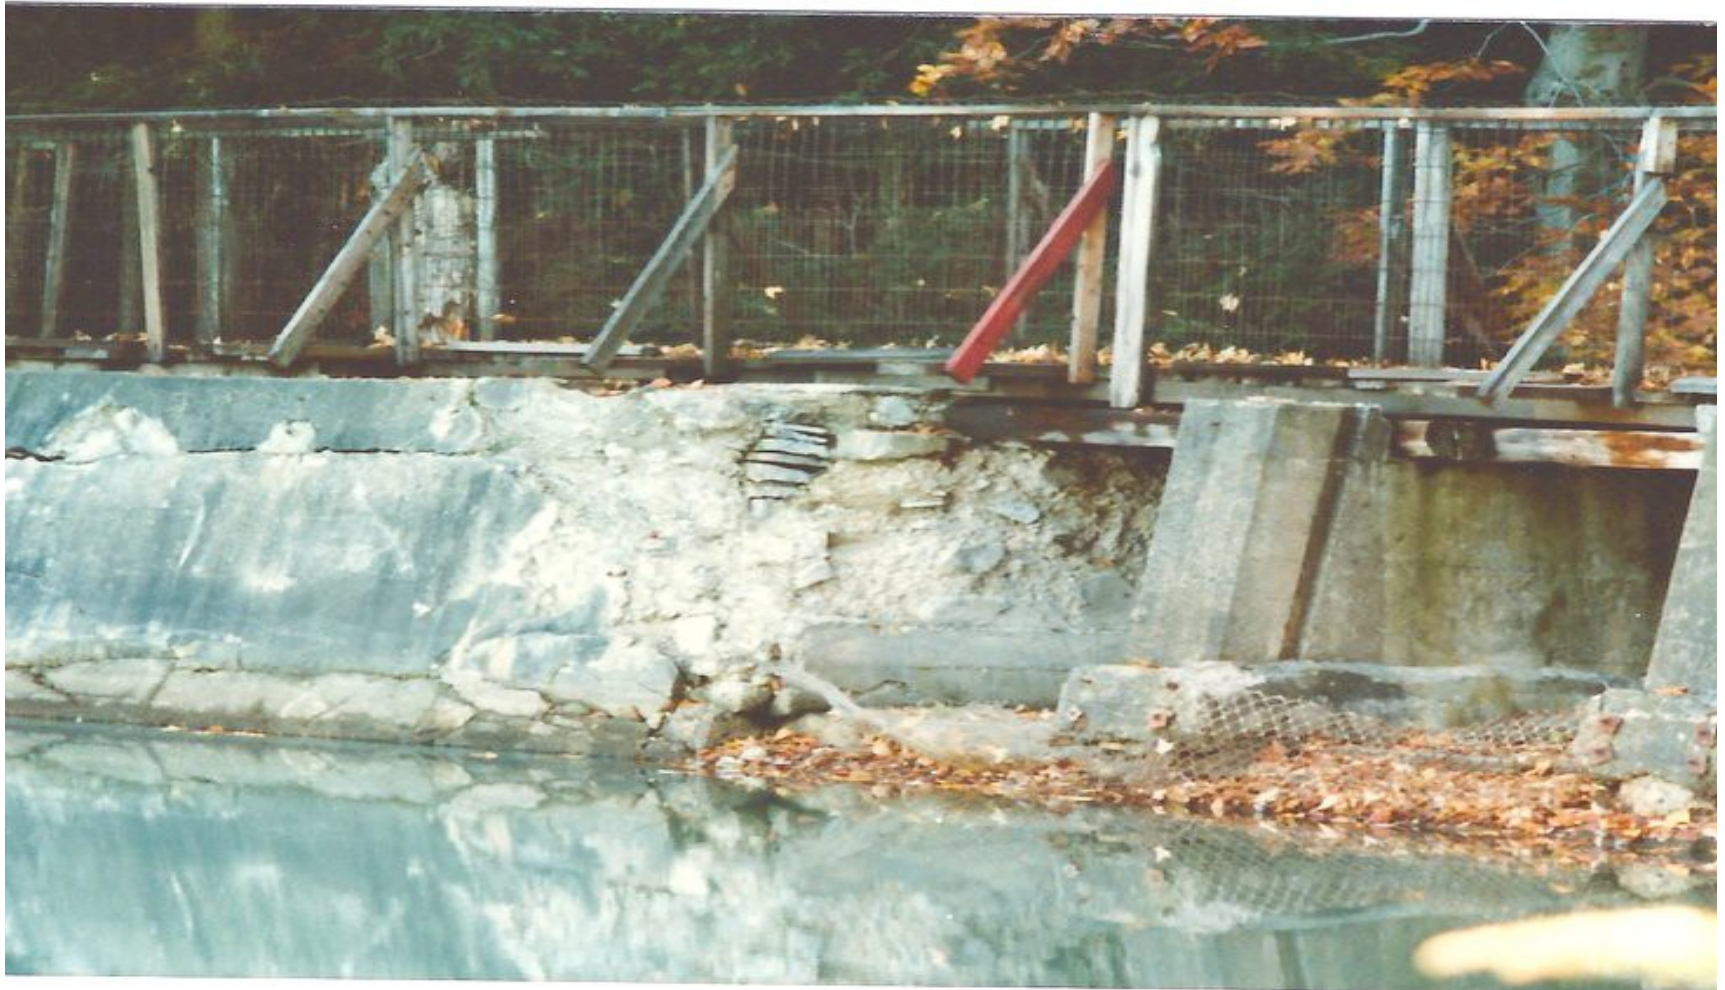
- 1. INADEQUATE SPILLWAY CAPACITY**
- 2. DETERIORATED CONCRETE OF UPSTREAM FACE OF DAM**
- 3. VOIDS UNDER BRIDGE PIERS**
- 4. DISPLACED STONE ON DOWNSTREAM FACE**
- 5. NO OPERABLE DRAIN**
- 6. SUBSTANTIAL LEAKAGE**
- 7. NO EMERGENCY ACTION PLAN**
- 8. LACK OF PRESCRIBED MAINTENANCE & OPERATION PROCEDURES**

Upstream face of dam

REMOVAL OF ALL DETERIOATED CONCRETE (SPILLWAY, PIERS, ETC.)

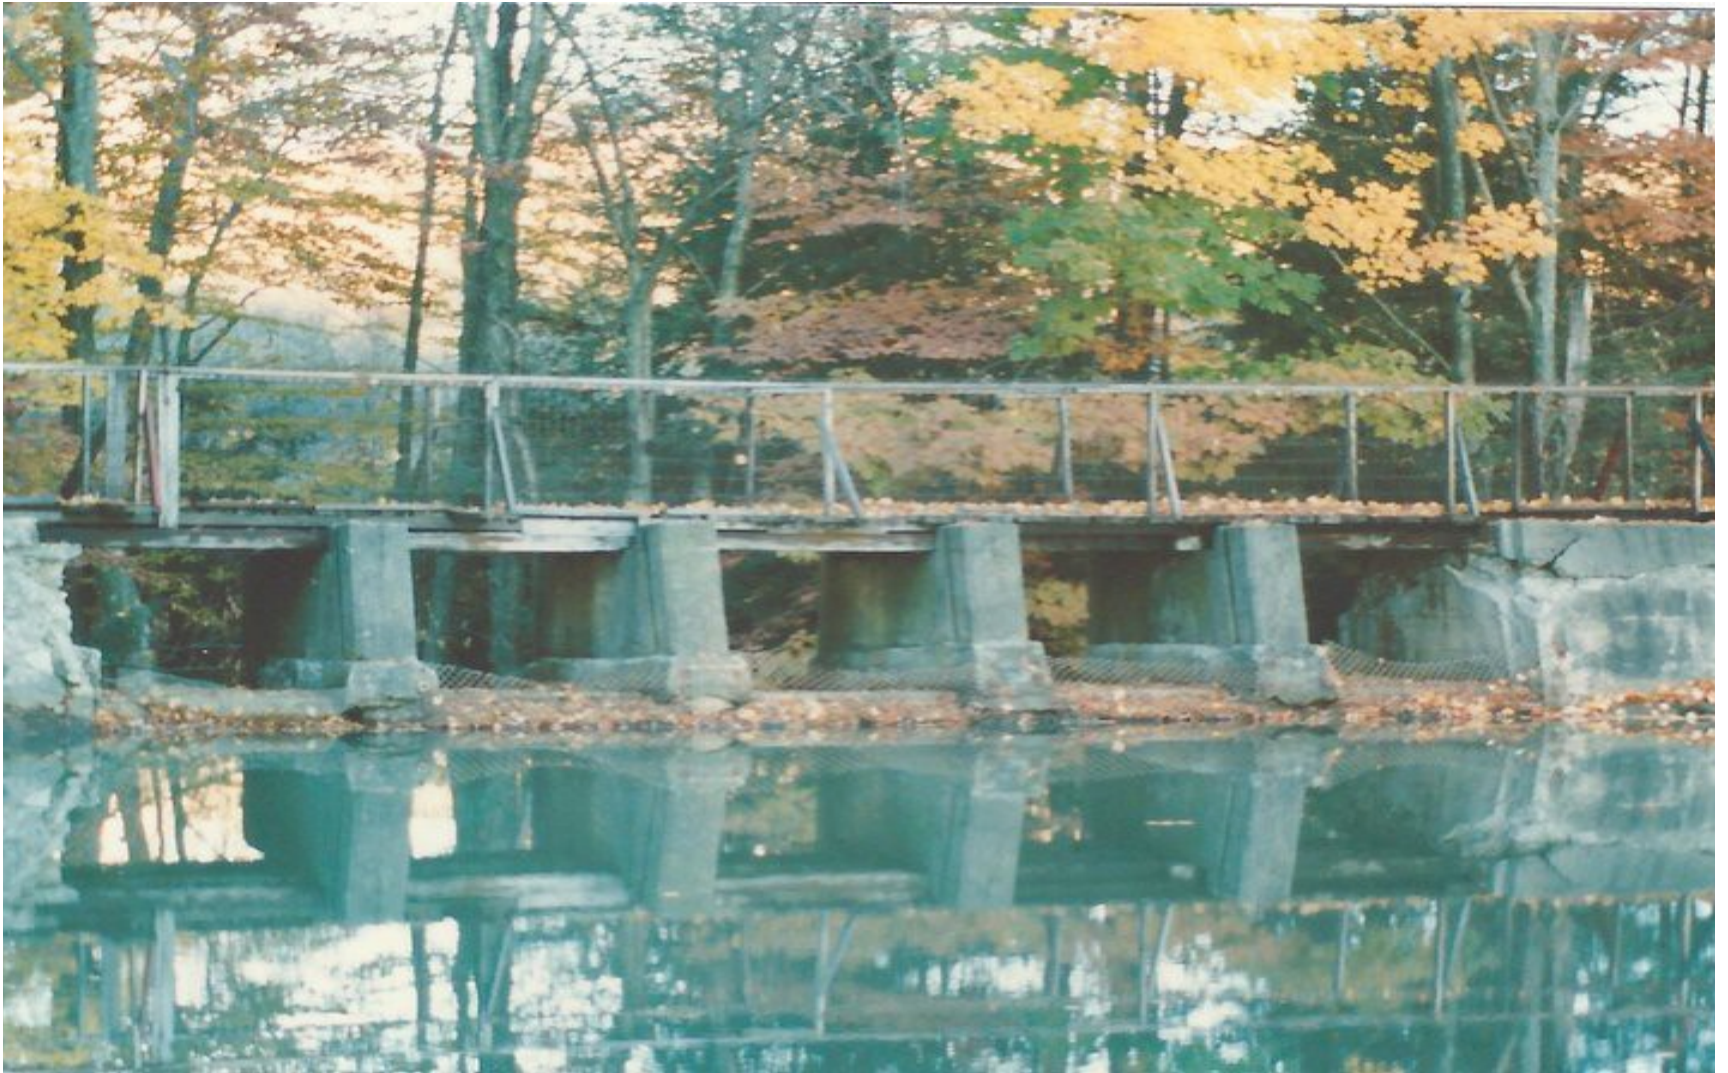
The main reason the dams have been called unsafe is that their spillways are too small to handle an accumulation of water from an unusually heavy storm without the lake water overflowing the top of the dam, Koch said.

Inadequate Spillway Capacity

MAKE THE EXISTING SPILLWAY ON THE DAM LARGER THEREBY ELIMINATING THE NEED FOR A LONG SWALE ACROSS PRIVATE PROPERTY. THIS WOULD ALSO ELIMINATE A LONGTERM MAINTENANCE ITEM.

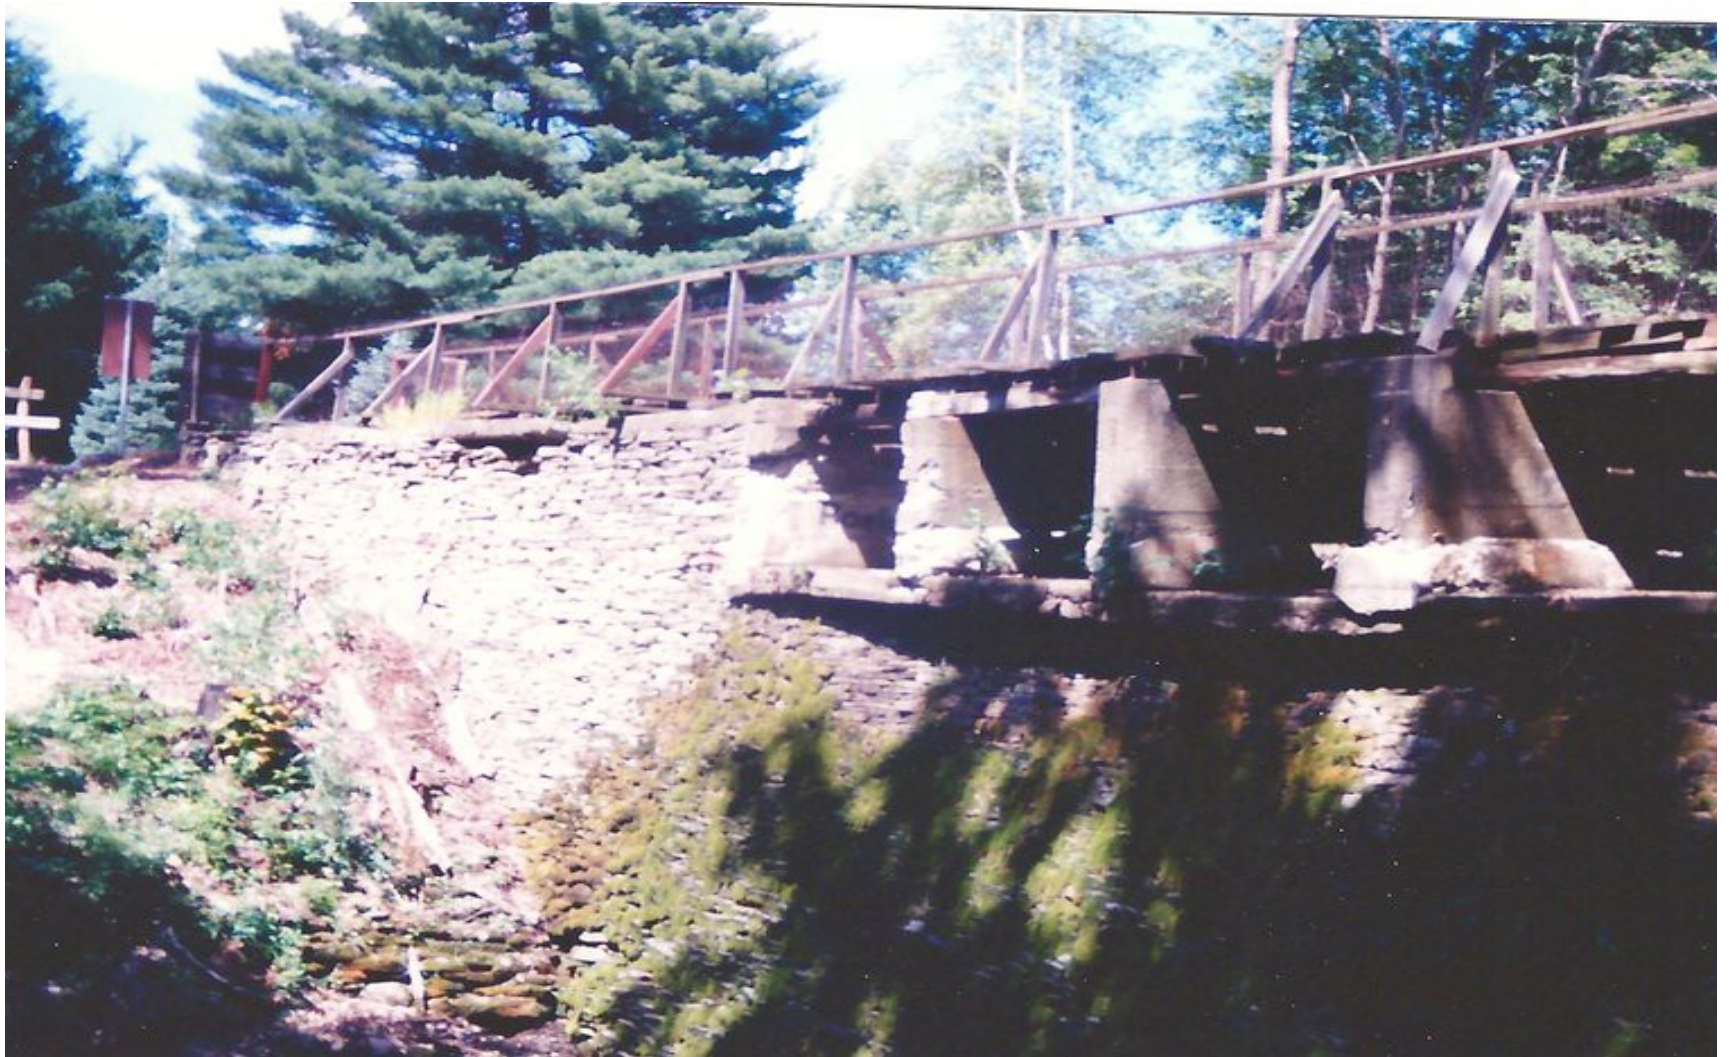
MISSING STONE AND DETERIORATED PIERS

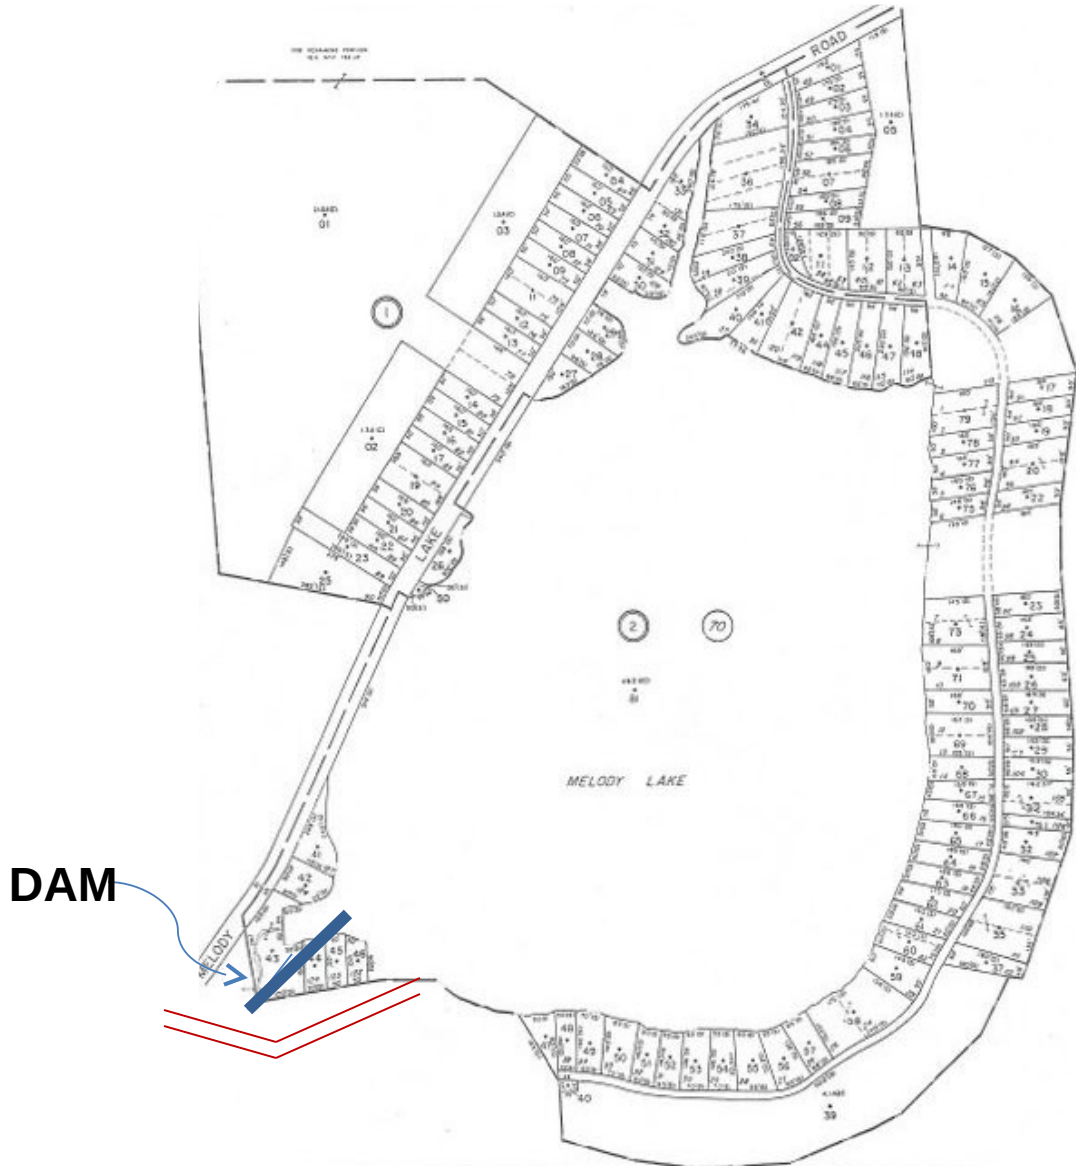
Proposed drain 12" x 250' x 2 =
500'

Proposed swale – 3'd x 45'w x
120'

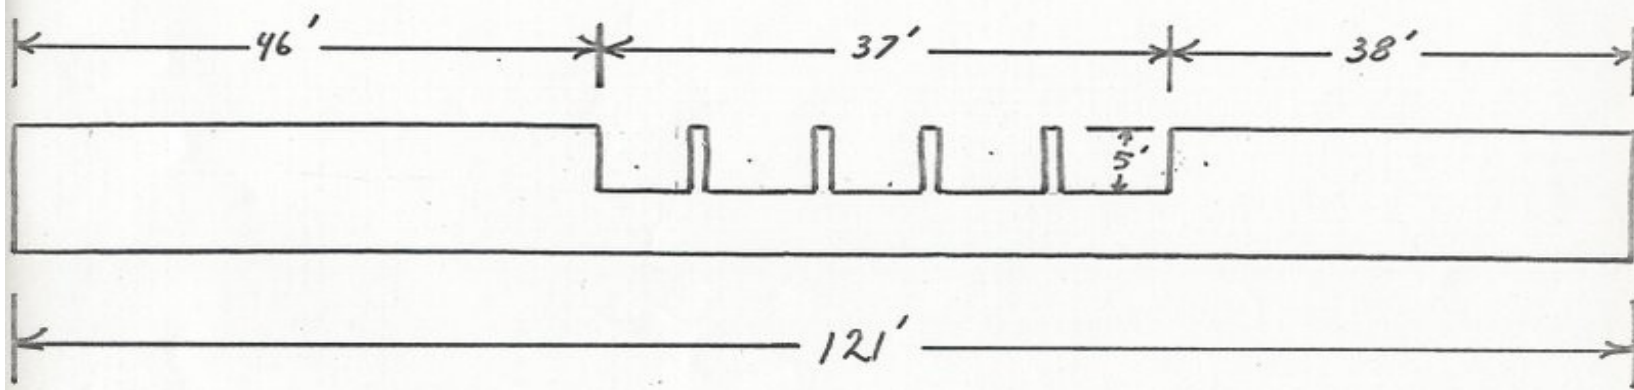
Original Spillway Approx. 150 ft²

Dam with Original Spillway

Proposal to remove 30' x 4' on both sides of the spillway

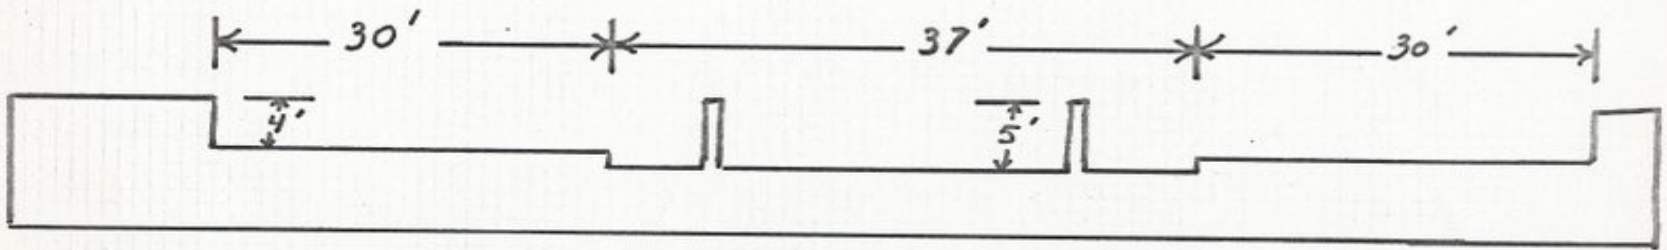
After removing both sections plus the removal of 2 piers
resulted in an additional 240 ft² for a total of 390 ft²
(an increase of 260%)

Final Spillway

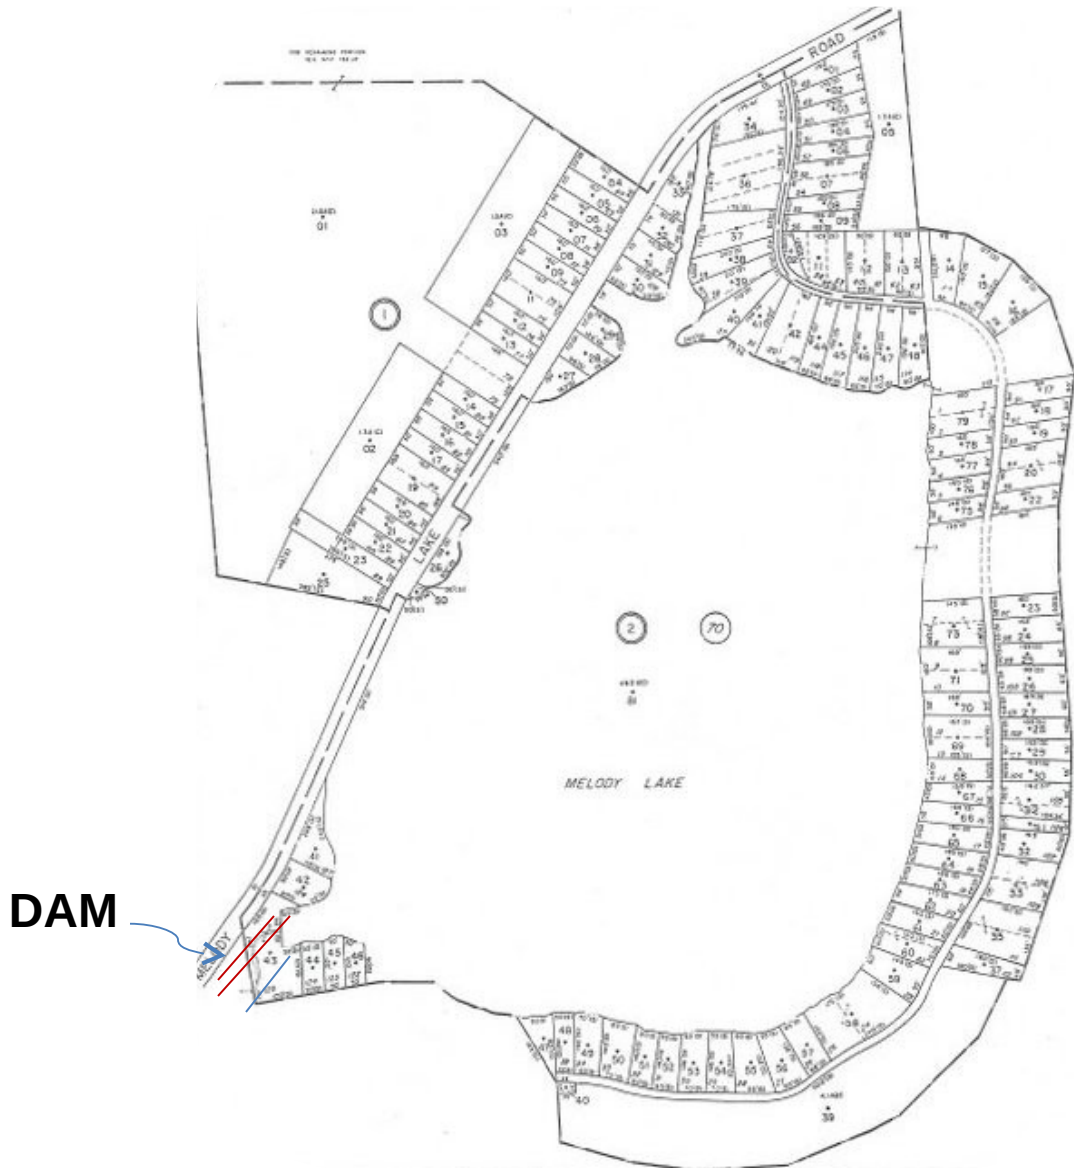
Proposed drain 12" x 250' x 2 = 500'

Final drain 12" x 110' x 2 = 220'

Proposed swale – 3'd x 45'w x 120'l
Final swale – 0'

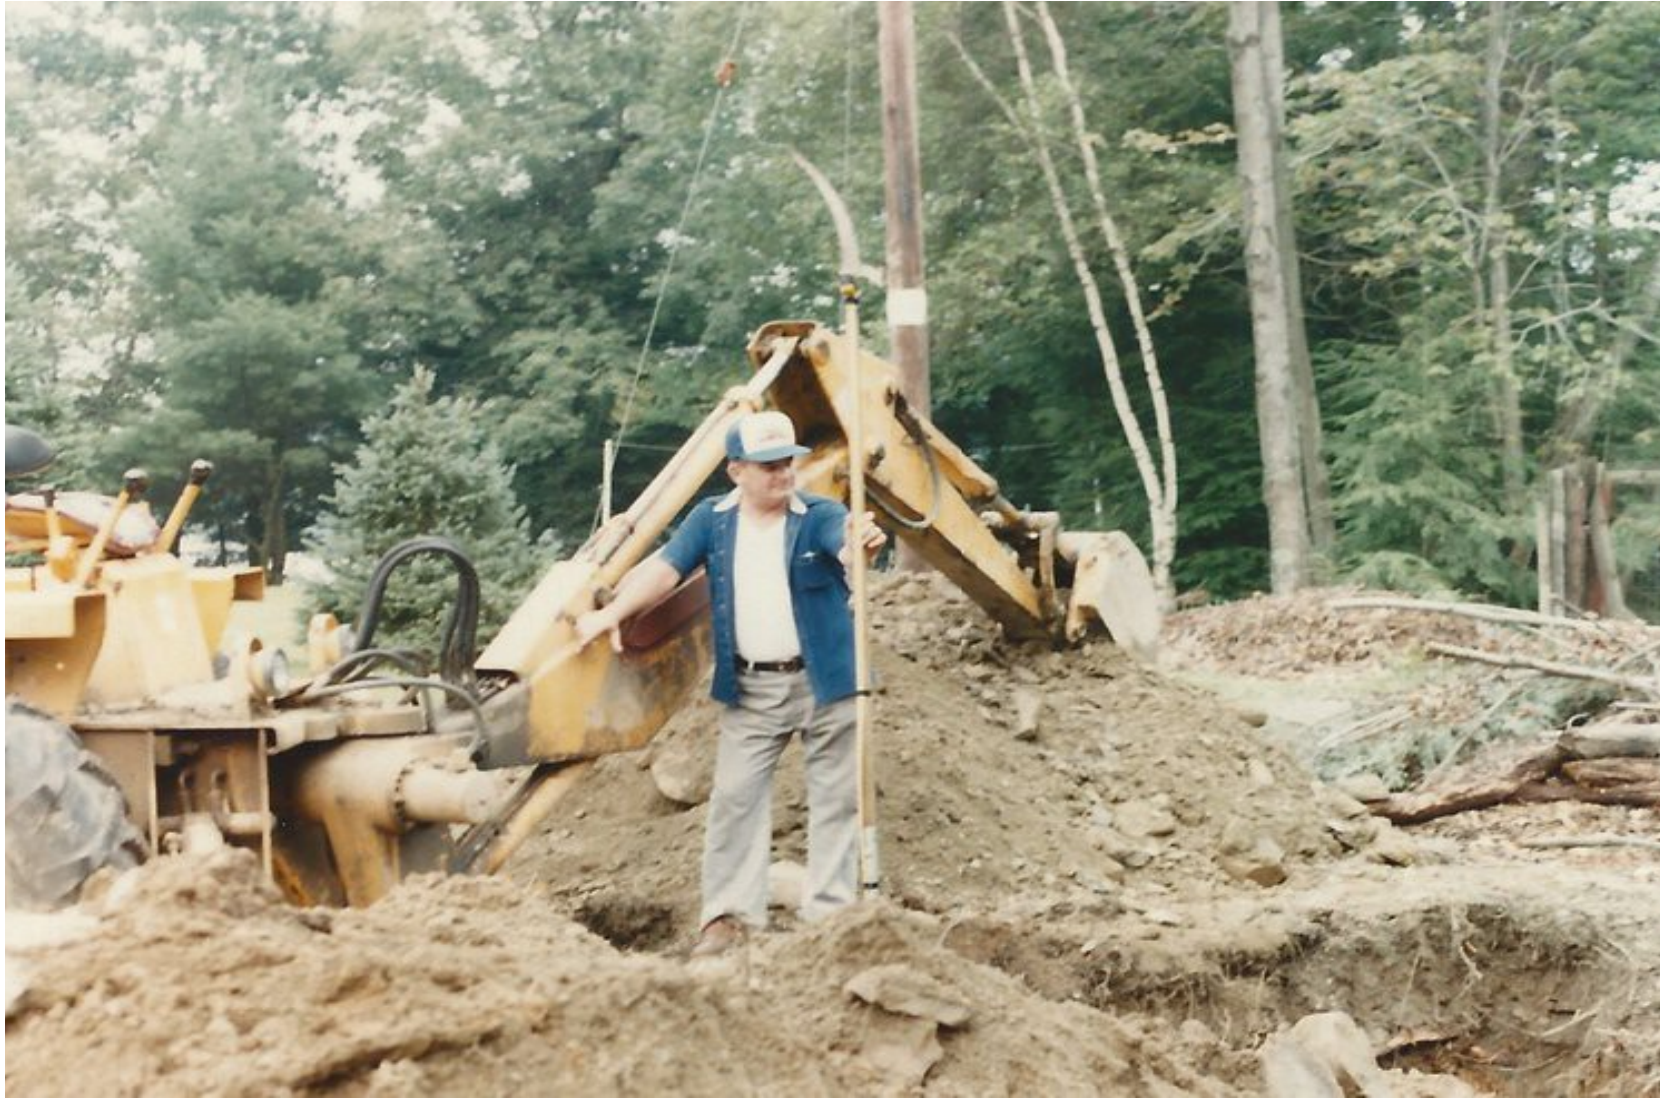
**TEST HOLES WERE DUG TO DETERMINE DEPTH OF
BEDROCK**

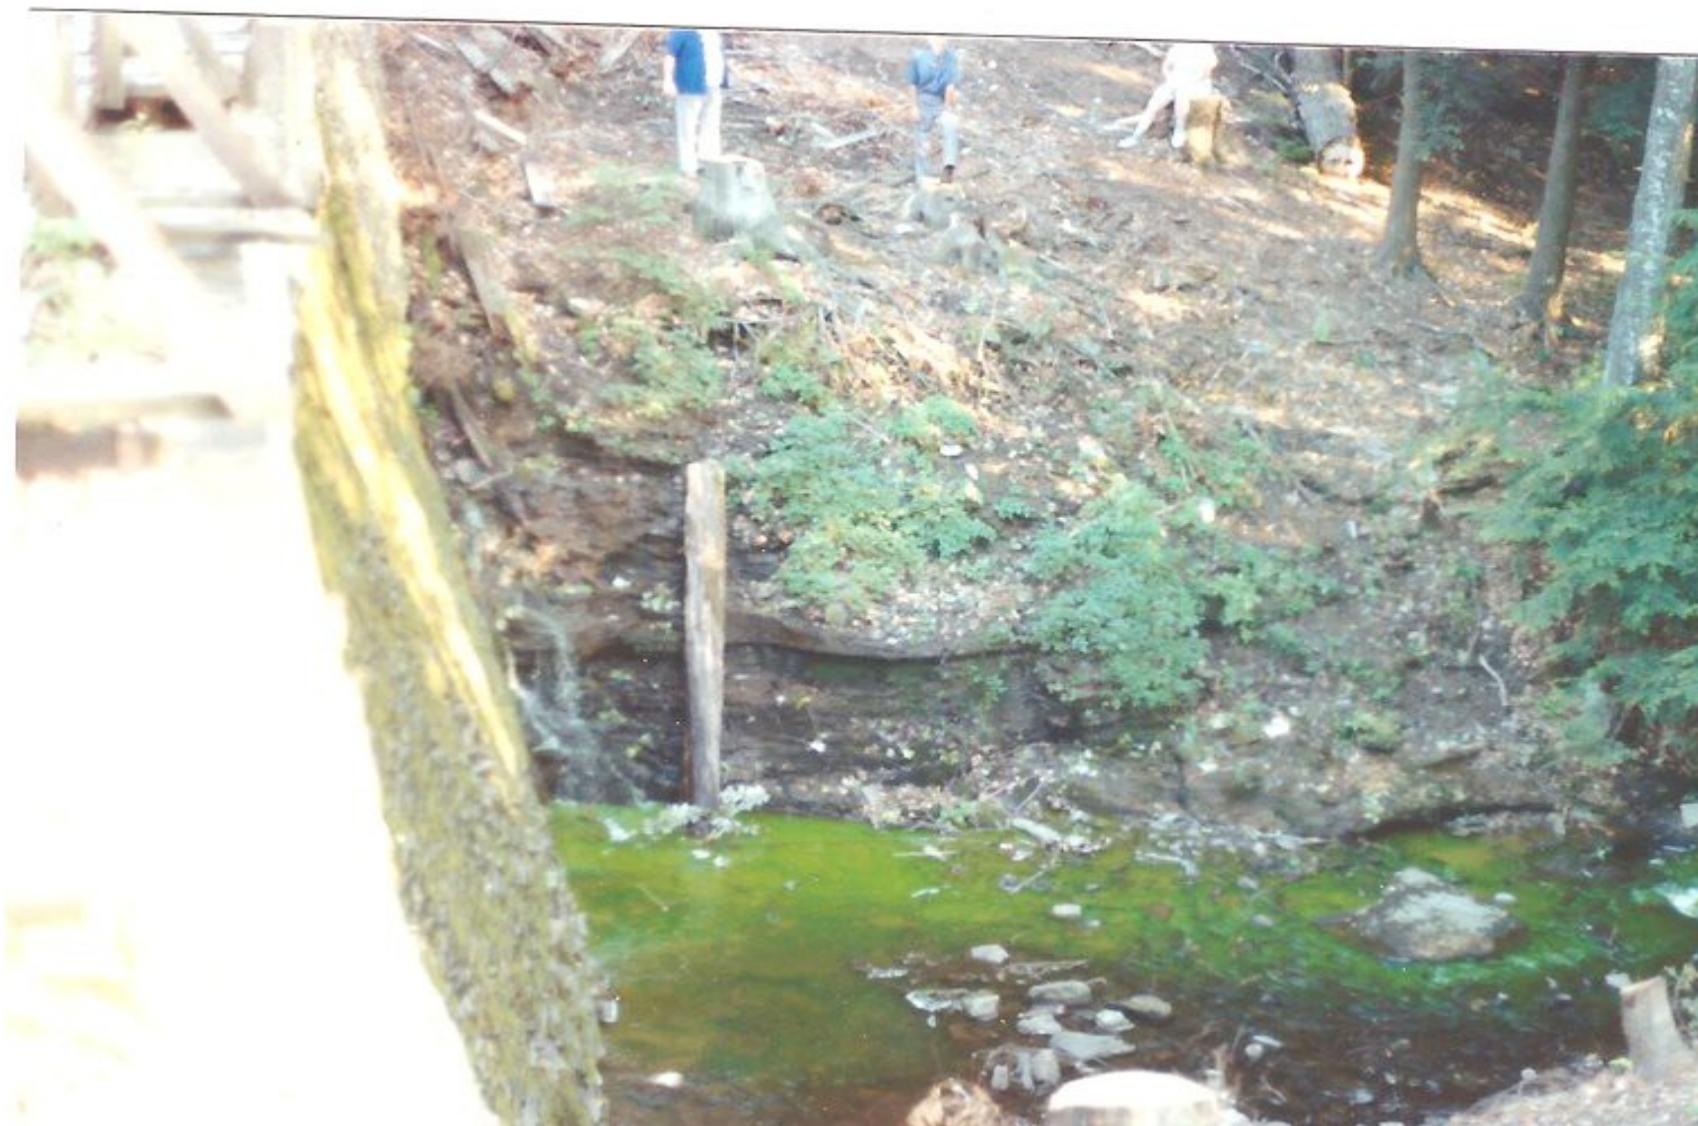
Dye was used to determine where the leakage was coming from

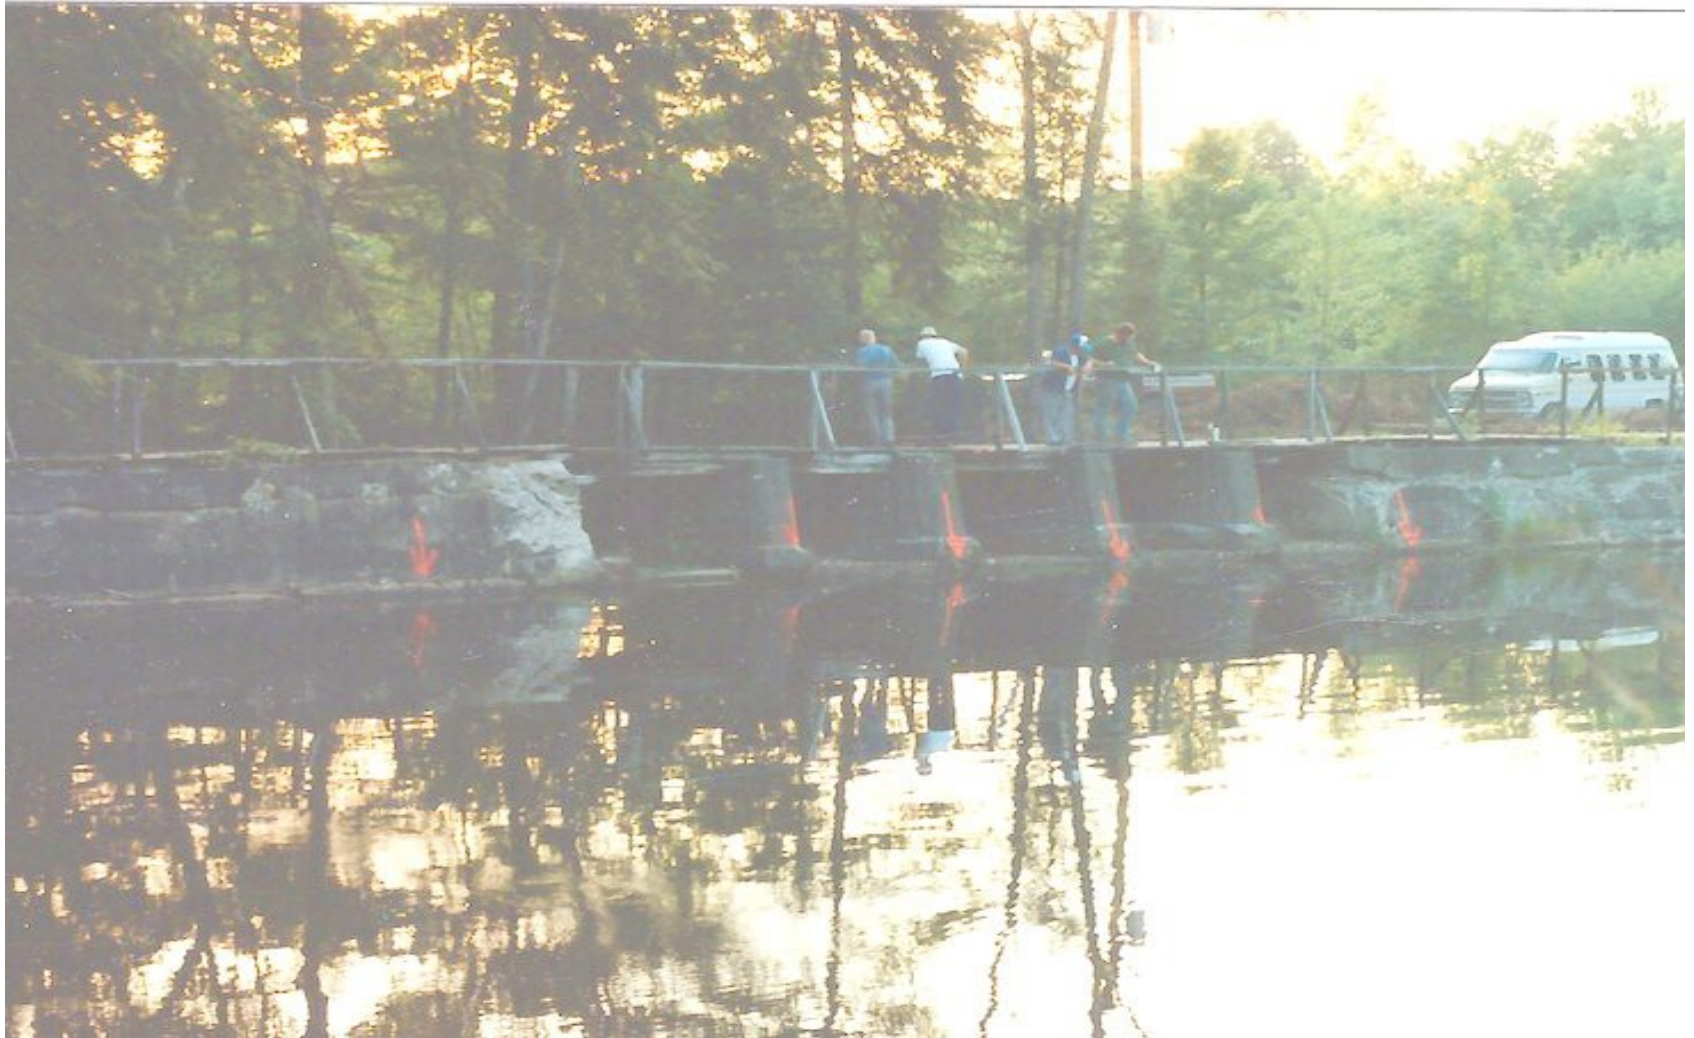
SECTIONS TO BE REMOVED WERE MEASURED AND MARKED

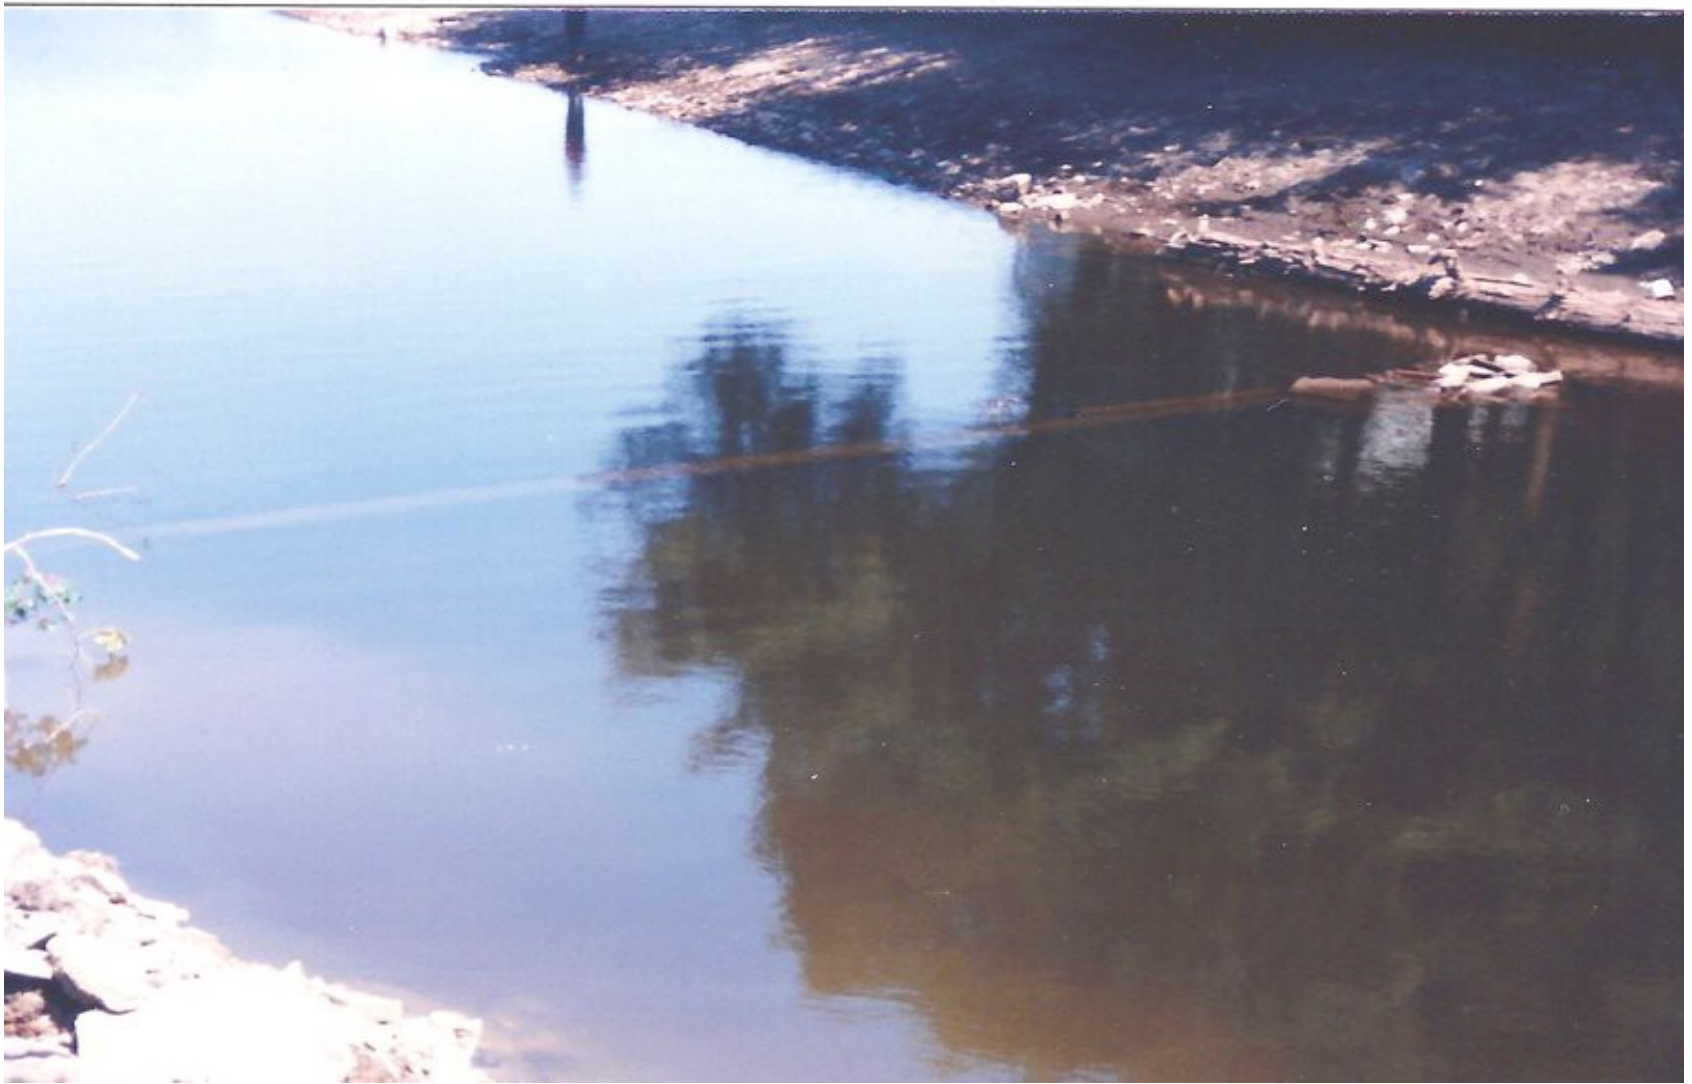
At this level, a wooden coffer dam which was constructed when the dam was built became visible

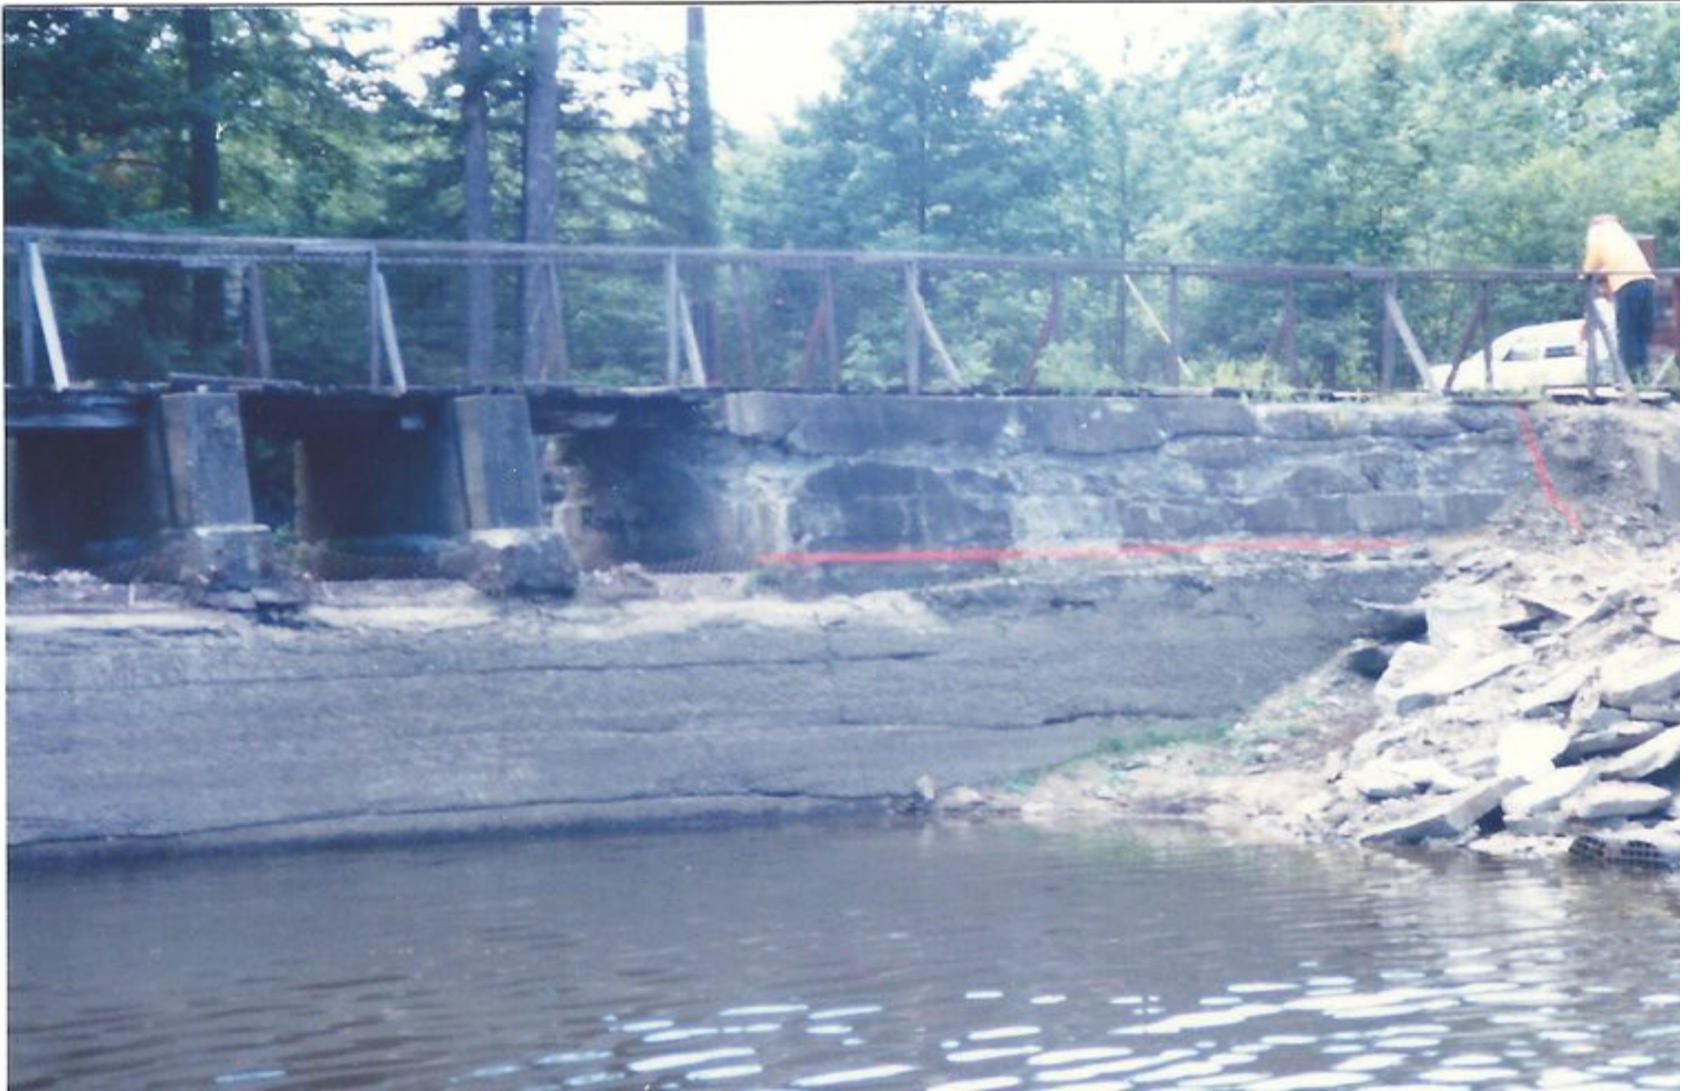
Upstream part of the dam to be removed for larger spillway

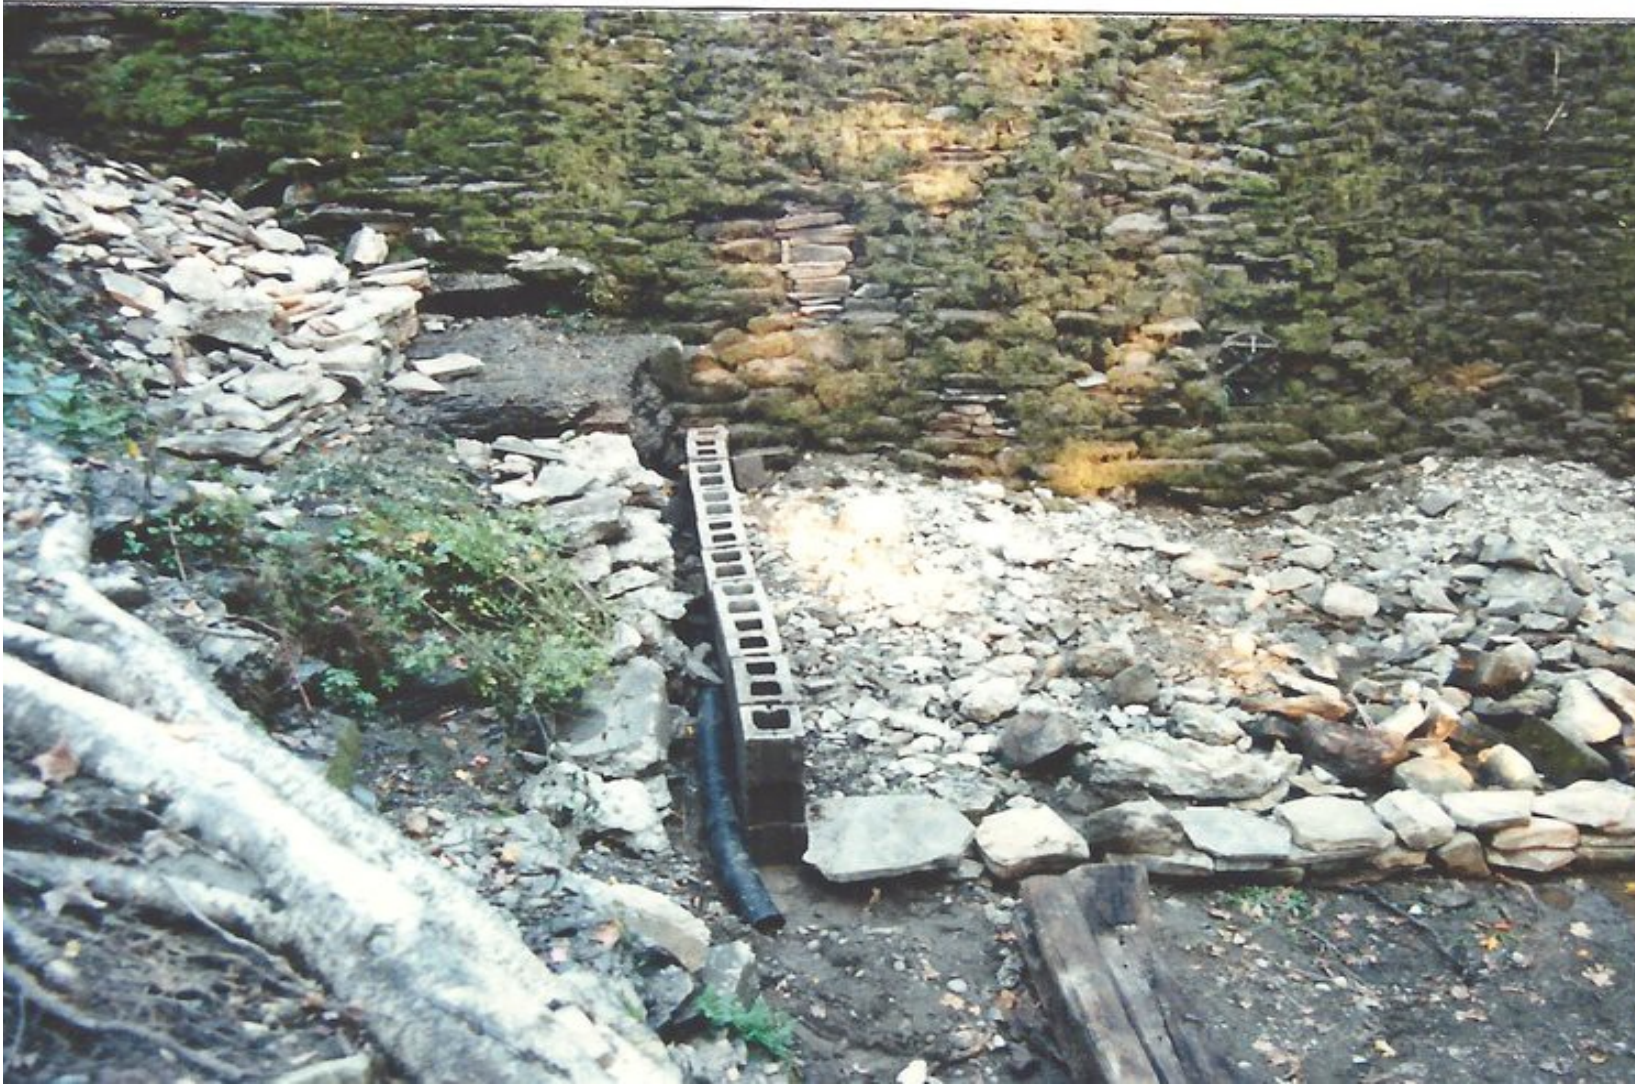
SINCE THE DAM RELIES ON ITS MASSIVE WEIGHT FOR STABILITY, DEC REQUIRED THAT ALL STONE THAT WOULD BE REMOVED SHOULD BE PLACED IN A BUTTRESS AT THE DOWNSTREAM TOE OF THE DAM TO COMPENSATE FOR THE LOSS OF WEIGHT FROM EXPANDING THE SPILLWAY. (REMOVAL OF ABOUT 110 CU. FT)

The stone that was removed for the larger spillway was placed at the downstream toe of the dam to reduce the possibility of sliding
